TSB 16-09-01 Emission System Purge Valve Hose Inspection: GM 3500/4500Series Cutaway with 6.0L gas engine

Symptom: Stalling after 3 or more hours of use. Inspect and repair as needed.

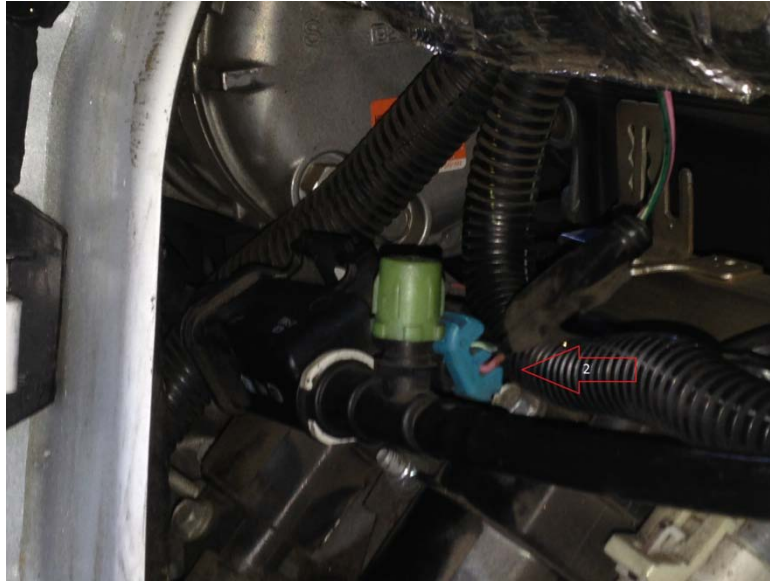
Image 1

Cause: The original Fuel Tank Purge Line, Manifold to Purge Solenoid, initially was a hard plastic line and replace with a Dayco 3/8" rubber fuel hose which was supplied with the Engine Kit. After time, the supplied rubber fuel hose is getting soft on occasion. This can cause the hose to kink due to the weight of the hose, required routing, degradation over time due to fuel additives such as Ethanol and coupled with under hood temperatures exceeding manufacture specs of 212°. The hose can kink on either end, but mainly at the Purge Solenoid side.

1. Remove engine cover
2. Remove Purge Solenoid electrical connector. (See image 1)
3. Slide Purge Solenoid upwards off the mounting tang.(See image 2)
4. Remove Purge Hose from Solenoid, located on the front side of the Solenoid. (See image 2)
5. Remove Purge Hose from intake manifold.(See image 3 & 5)
6. Cut rubber hose leaving 3" of Hose on both Purge Hose Connectors.(See image 4)
7. Insert Hard Plastic 3/8" fuel line into trimmed rubber fuel line until it contacts the end of the barbed nipple.(See image 3)
8. Reinstall Hose, Purge Valve and Purge Valve Connector and Engine Cover.
